PROJECT PROFILE:
Museum of Natural History & Science
Sustainable. Seamless. Solutions.

Museum of Natural History
& Science

Albuquerque, New Mexico

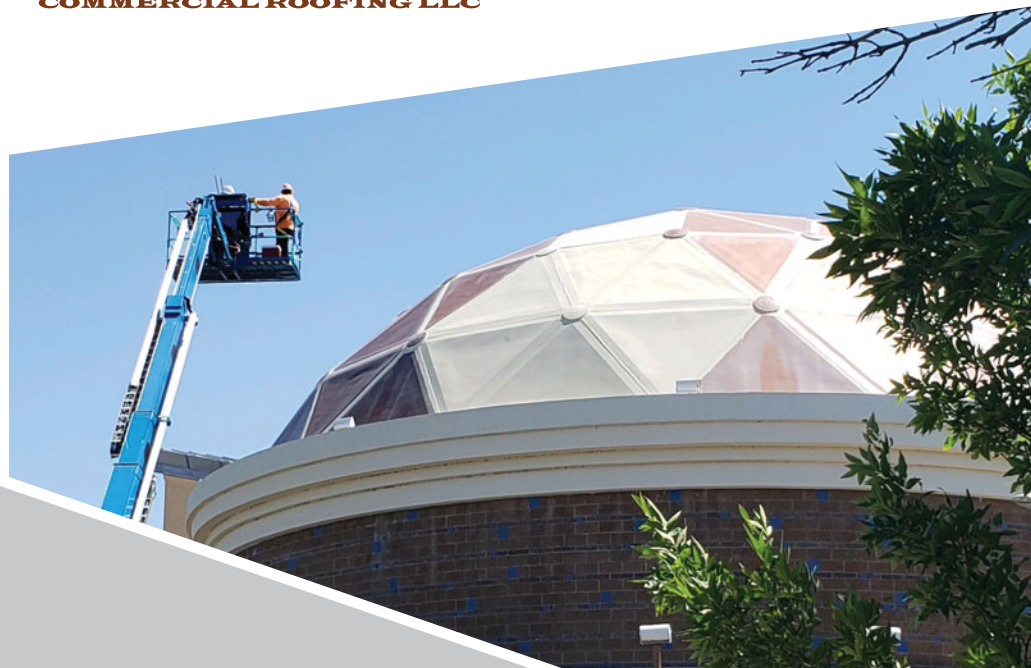
One of the most popular features of the museum is its 55-foot, full-dome planetarium and theater. Unfortunately, visitors were getting more than a glimpse of the stars, as the dome's 80-foot-high roof began experiencing leaks from expanding seams and years of weathering.

The crew from Commercial Roofing began by washing the entire roof and applying CRFC's SeamlesSEAL® ULTRA LS silicone coating—with Seal-Tek Micro Fibers mixed in—to all seams to restore their watertight integrity. Seal-Tek Micro Fibers are micro-fine, high-tensile polyethylene fibers that thicken the SeamlesSEAL coating into a roller-applied or brushable mastic. The fibers are easy to mix into pails of coating and are ideal for repairs and rough substrates.

The crew then roller-applied two layers of CRFC SeamlesSEAL ULTRA LS tan silicone coating, one triangle at a time and then applied two coats of the SeamlesSEAL ULTRA HSLV silicone coating in the color coppertone. This single-component, moisture-cured, fluid-applied silicone coating is specially formulated to meet low-VOC requirements and has excellent resistance to water intrusion, UV exposure, and natural weathering.
